### East Peak, Ted's Buttress Incident, February 6th 2016 Report prepared by Crystal Mountain Pro Patroller Peter Dale and NWAC

Incident snapshot

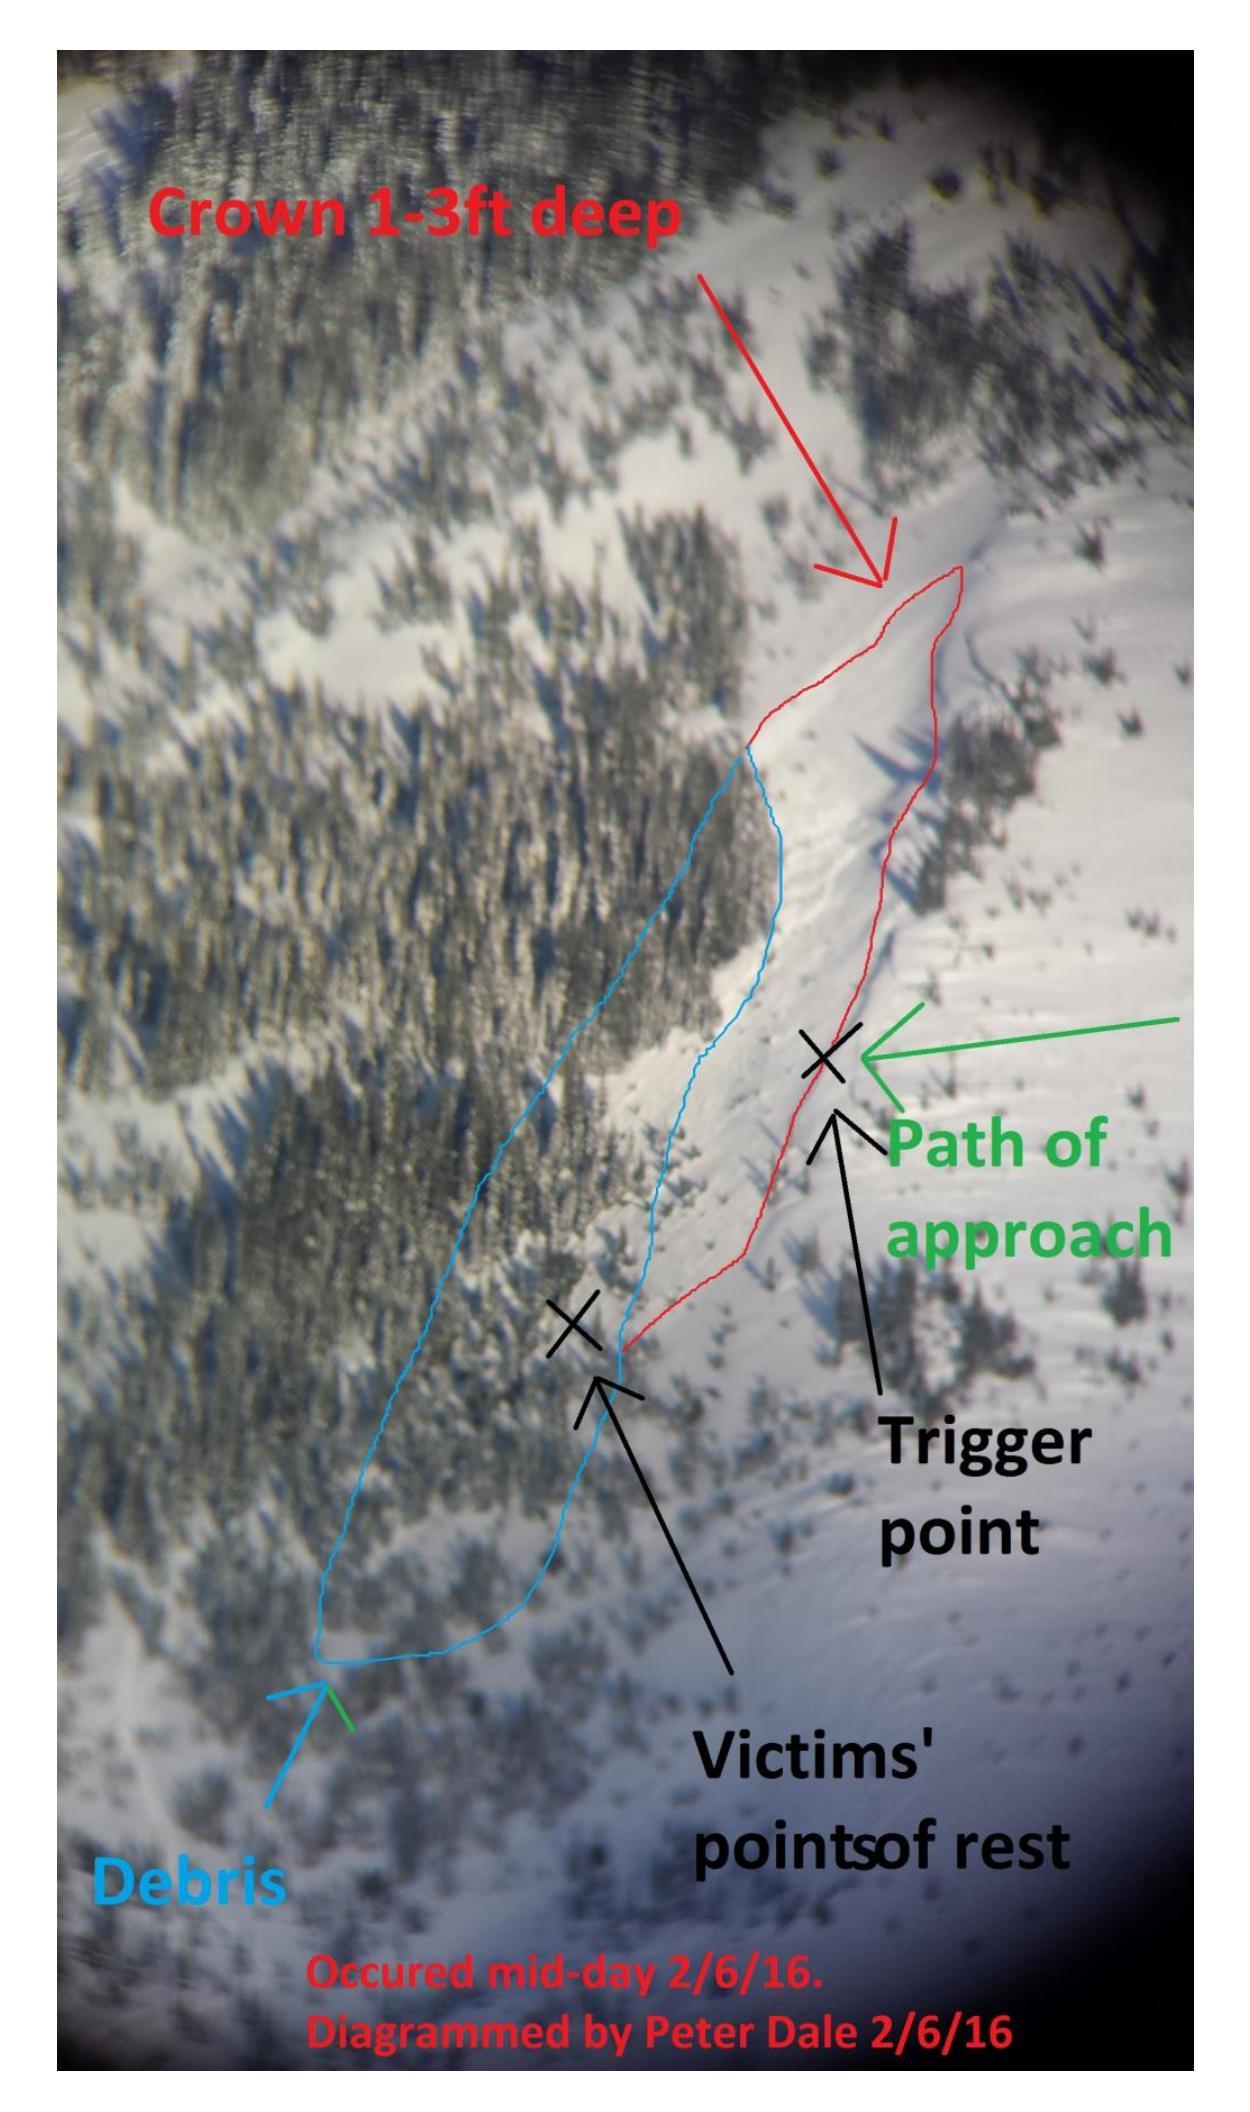
# View looking east from top of gondola at Crystal Mt.

- Avalanche 7/

- - Diagrammed by Peter Dale 2/6/16

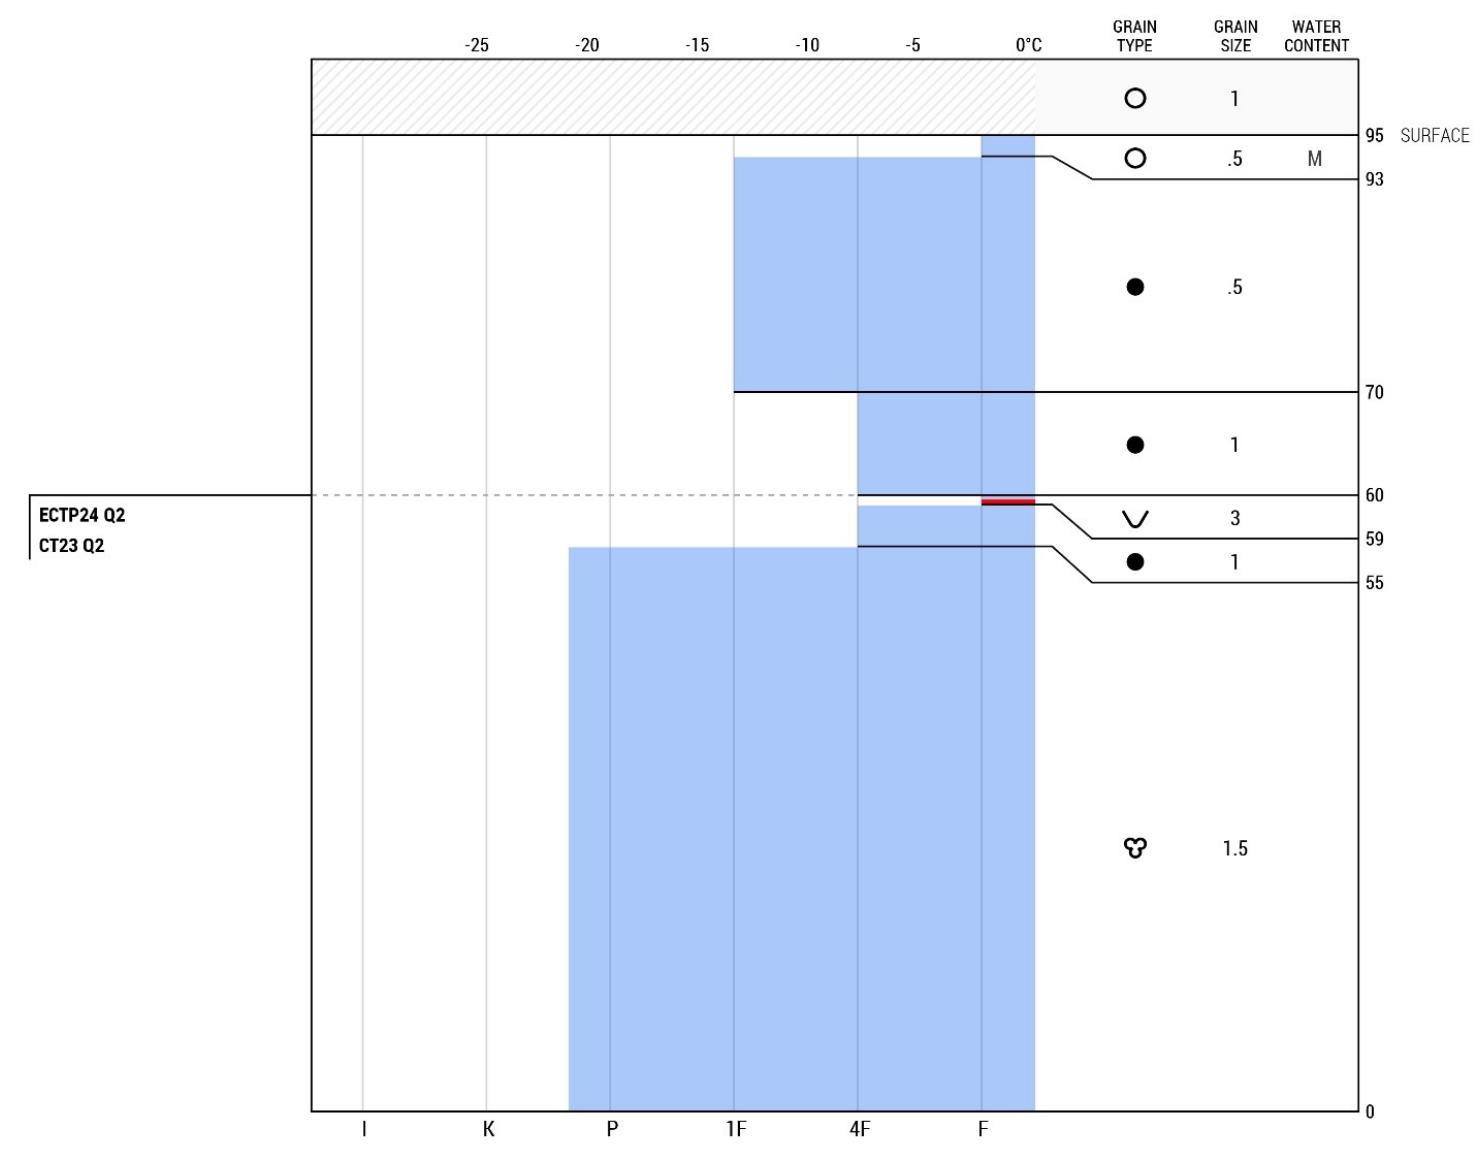
## **Avanet** SNOW PROFILE

Elevation:	5,900 ft	Wind:	Calm	Fracture profile of ss-as-r3-d3 that released on SH (likely formed 2/1/16) at 60cm. Pit was dug on corniced
Slope:	27°	Blowing snow:	Previous	ridgeline at trigger point, with HS >415cm. HS measured on bed surface averaged 150cm. Crown
Aspect:	325° NWbN	Precipitation:	No Precipitation	ranged in depth from 10cm to 130cm.
Air temp.:	6.0°C	Foot Pen. (PF):		
Sky: 🔿	Clear	Ski Pen. (PS):

**Snowpack** Describe the state of the snowpack. Include season history, snow profiles, and prominent features as necessary. New snow and windslab on top of a crust from a large rain event on 1/28/16. Embedded and protected within the new snow was some surface hoar that likely formed on 2/1/16 and 2/2/16. Snowpack below raincrust from 1/28/16 was well consolidated and rounded. Snow pit from trigger site attached.

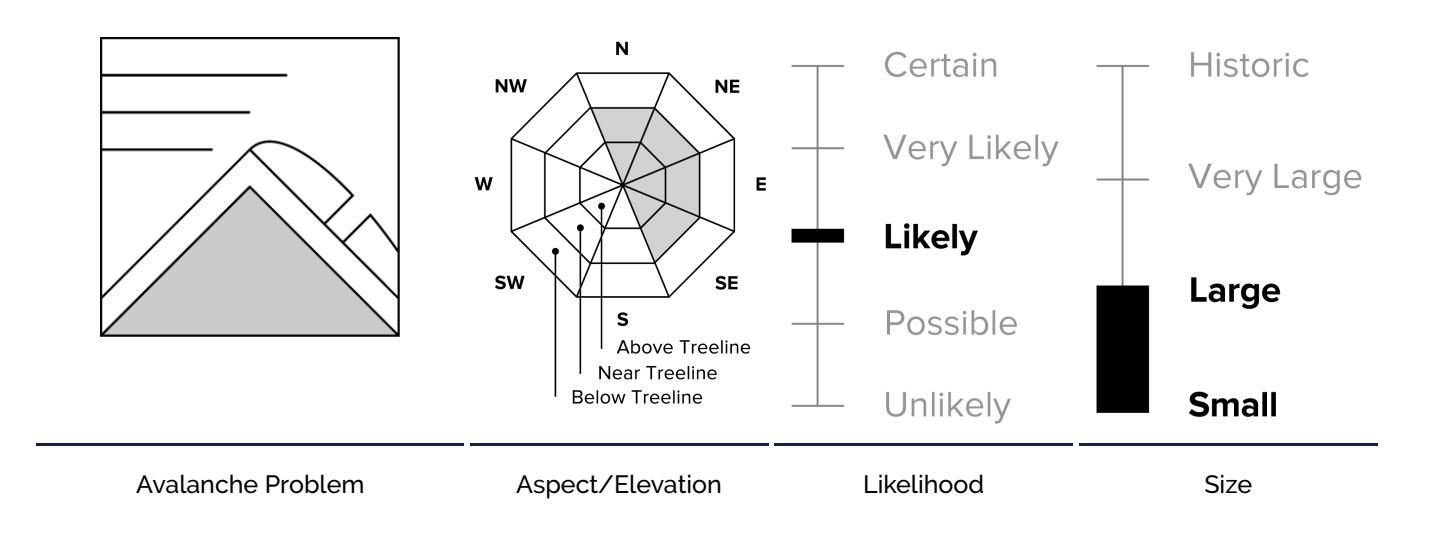
### Wind Slab

Wind slabs can take up to a week to stabilize. They are confined to lee and cross-loaded terrain features and can be avoided by sticking to sheltered or wind scoured areas.

The main avalanche problem should be new wind slab on lee slopes in the near and above treeline. Watch for signs of snowpack cracking and firmer wind transported snow on lee slopes.

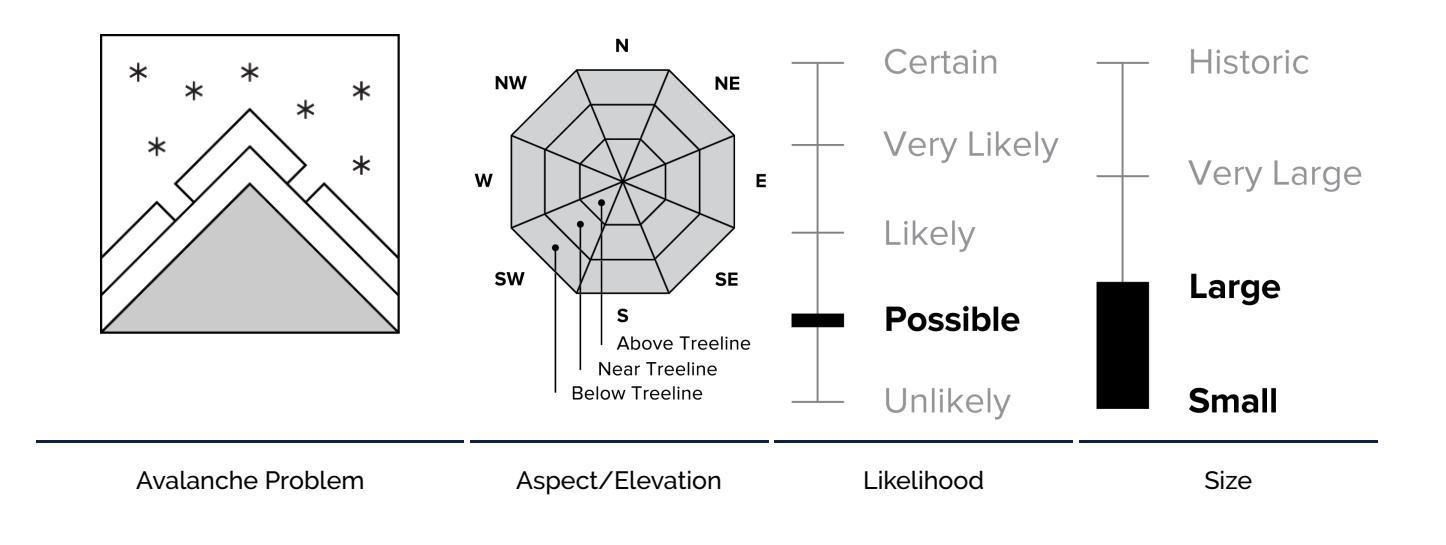
### Storm Slabs

Storm slabs usually stabilize within a few days, and release at or below the trigger point. They exist throughout the terrain, and can be avoided by waiting for the storm snow to stabilize.

A secondary avalanche problem should be new storm slab in areas with less wind if there is rapid loading. The cooling trend may help limit this avalanche problem.
